INVESTIGATION OF FALL PROTECTION FOR  
RESIDENTIAL ROOF CONSTRUCTION AND REPAIR IN HAWAII

A THESIS SUBMITTED TO THE GRADUATE DIVISION OF THE UNIVERSITY  
OF HAWAII IN PARTIAL FULFILLMENT OF THE  
REQUIREMENTS FOR THE DEGREE OF

AUGUST 1997

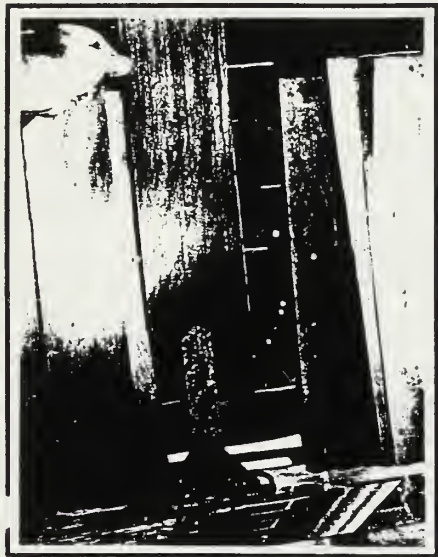
**PR 20 EAVE CATCHGUARD RAFTER BRACKET** can be easily shingled over using asphalt shingles, cedar shakes or almost any other type of roofing material. Then when the job is complete simply pull out the coupling pin, insert bracket knockout, tap up and the rafter bracket will slide off the nails.

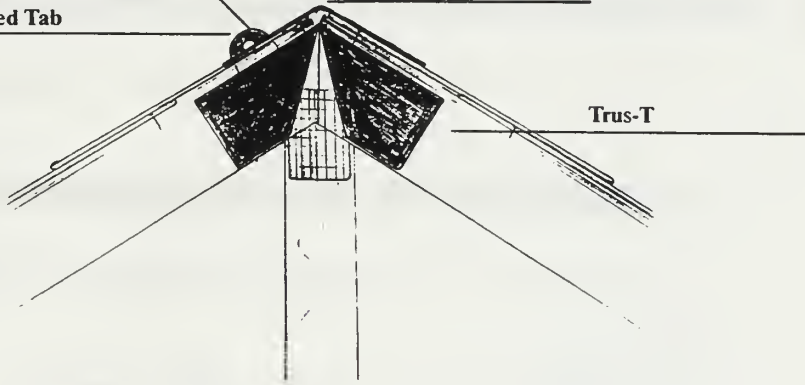
The Trus-T is designed to be installed before the trusses are raised onto the walls. Place a Trus-T on every fourth truss while the trusses are on the ground.

When the trusses are in place at 2' o.c., the anchors will be properly spaced. Now all workmen from the framer through the roofer can be "in compliance".

The tab can be either bent over to complete the roof or left exposed (see detail) for use by the building owner for maintenance and repairs.

Testing of the Trus-T anchor took place in 1,000 lb. increments to determine if any deformation was evident in the device. None was noted. Final loading of the device took place at 5,400 lbs. with minimal deformation visible.

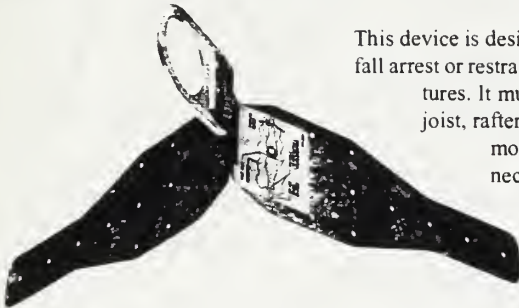
### Single-Mount Roof Anchor

This device is designed to be an anchorage connector for personal fall arrest or restraint systems used on flat or sloped wood roof structures. It must be nailed (16d [penny]) into the sheathing and joist, rafter, etc. (roof member). Specifically designed to be mounted only once (ie. remove and destroy or cut connecting D-ring off and shingle over).

Length When Flat = 22" • Wt. = 1.8 lbs.  
Minimum Breaking Strength = 5,000 lbs.

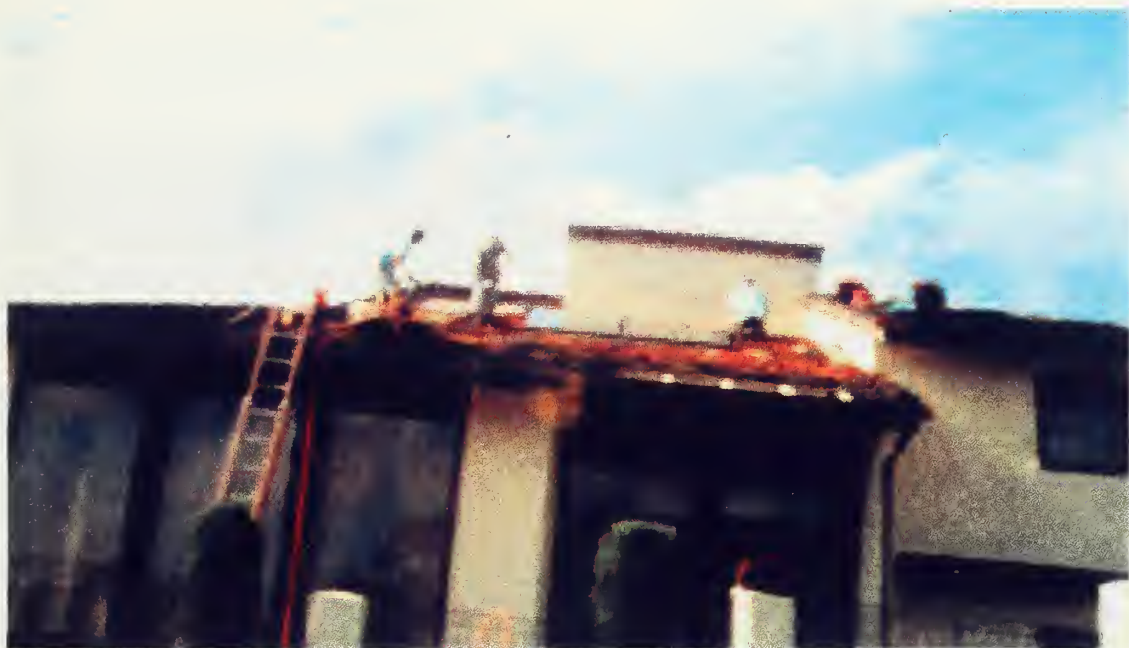
**Figure B.1: Partial reroofing project, Aiea; no protection in use**

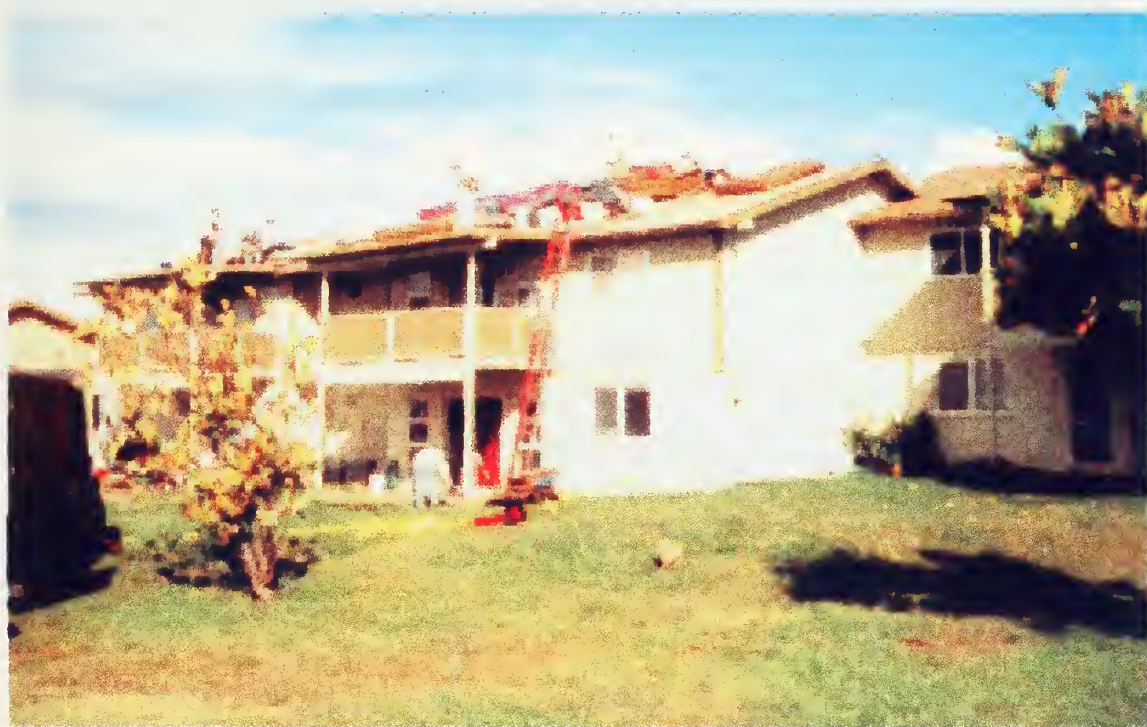
**Figure B.2: Reroofing job, Marine Corps Base Hawaii, Kaneohe; PFAS in use**

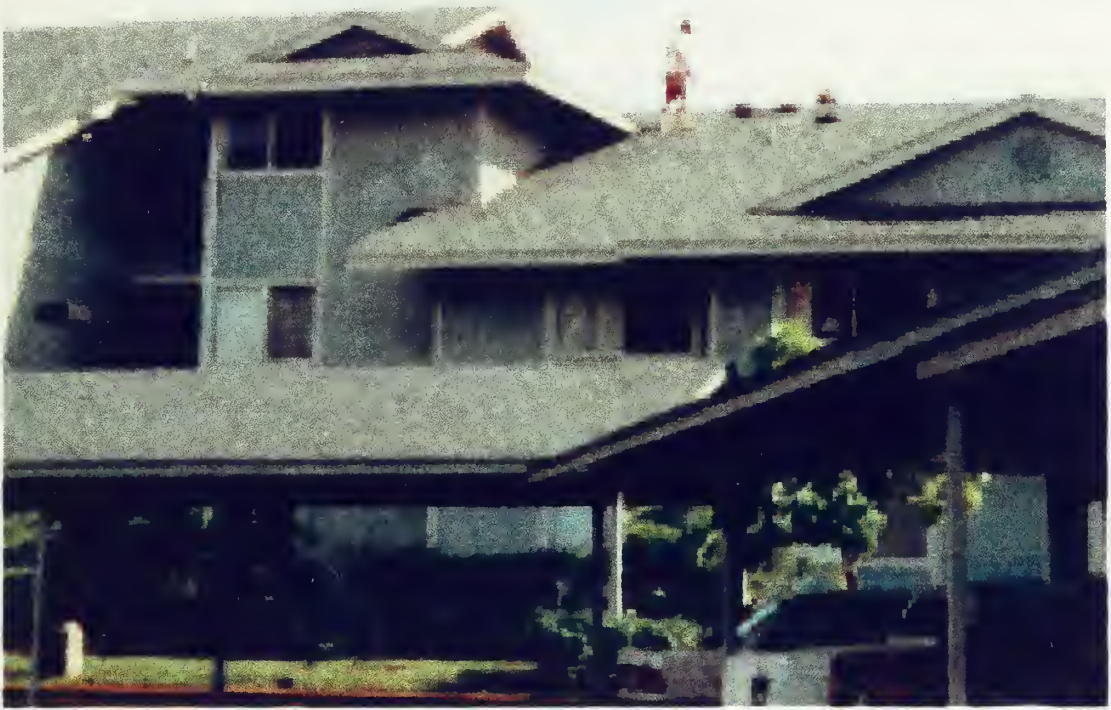
Figure B.3: Finish work, central Oahu; no protection

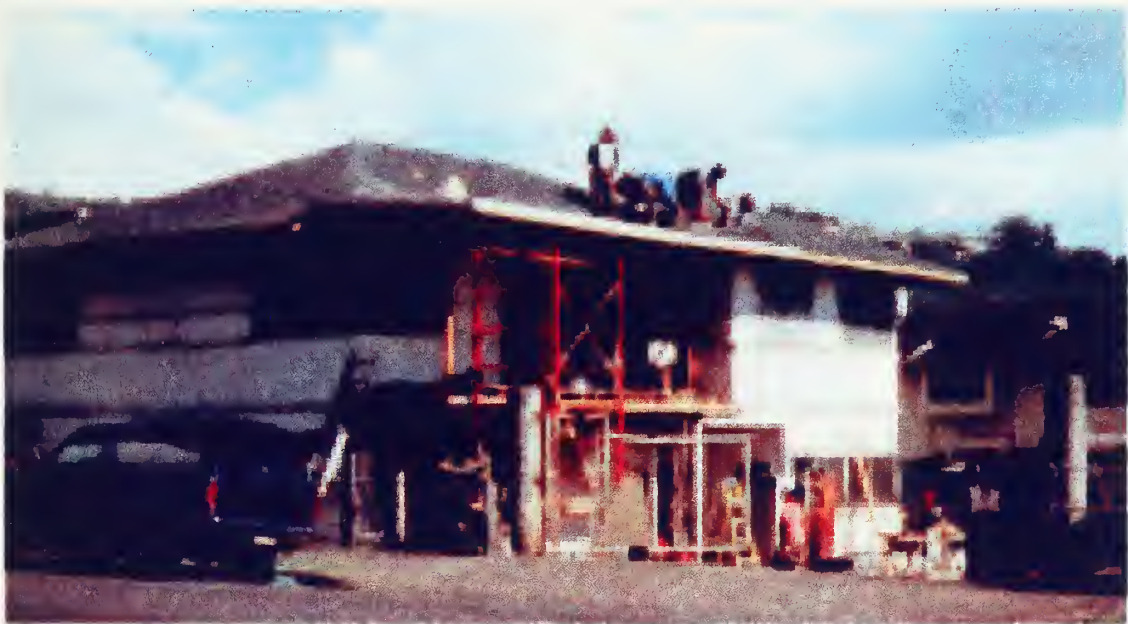
Figure B.4: Renovation project, Honolulu; no protection

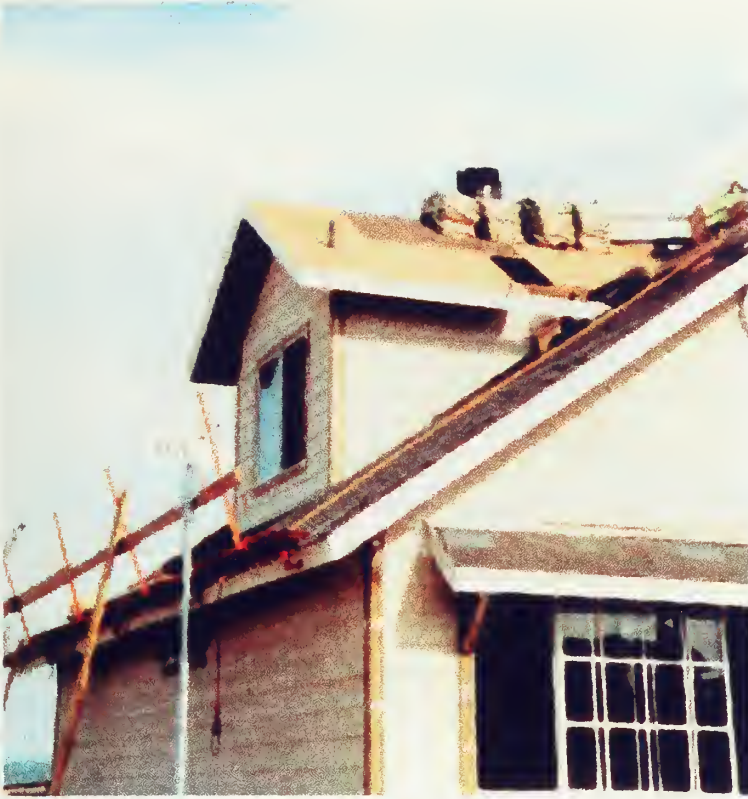
**Figure B.5: New construction, Ewa Beach; PR20 Eave Catchguard system and Trus-T PFAS variant, end view**

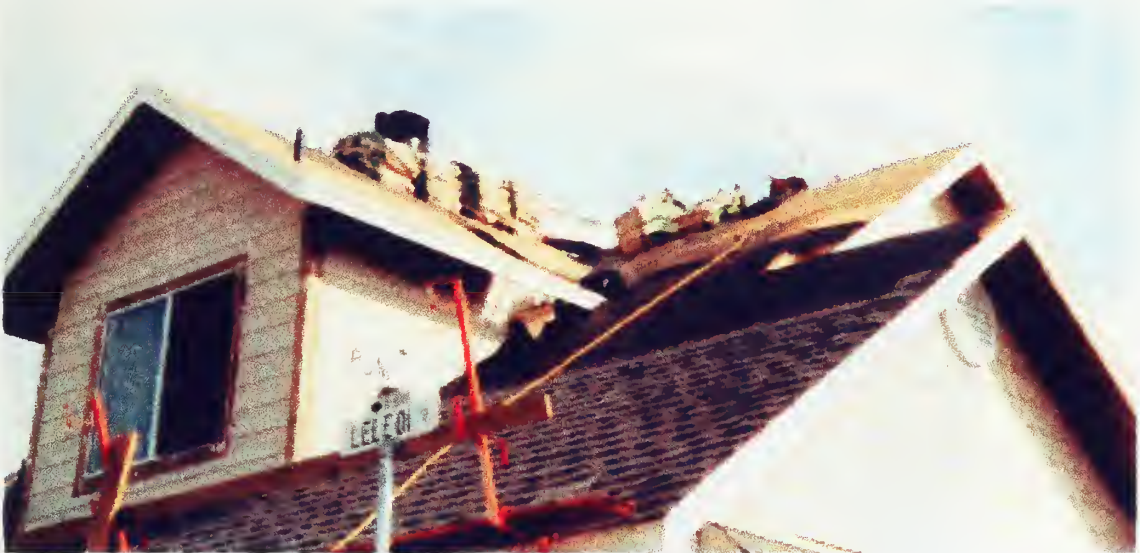
**Figure B.6: New construction, Ewa Beach; PR20 Eave Catchguard system and Trus-T PFAS variant, corner view**

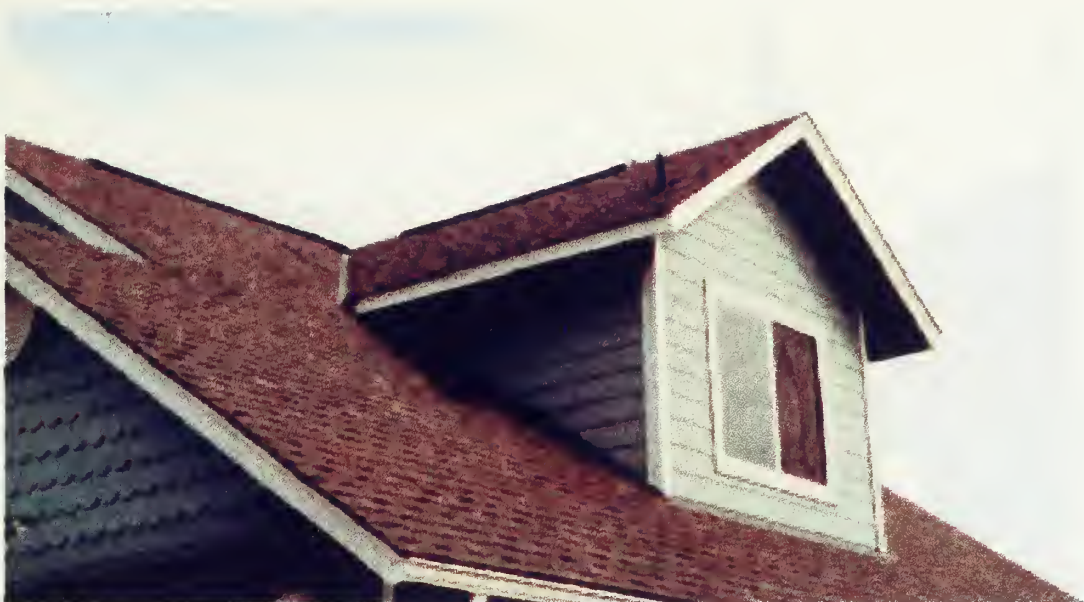
**Figure B.7: New construction, Ewa Beach; finished roof with permanent Trus-T anchor system installed on ridge (Note slightly raised portion of ridge cap; Trus-T anchors are spaced evenly along ridge in this raised portion.)**

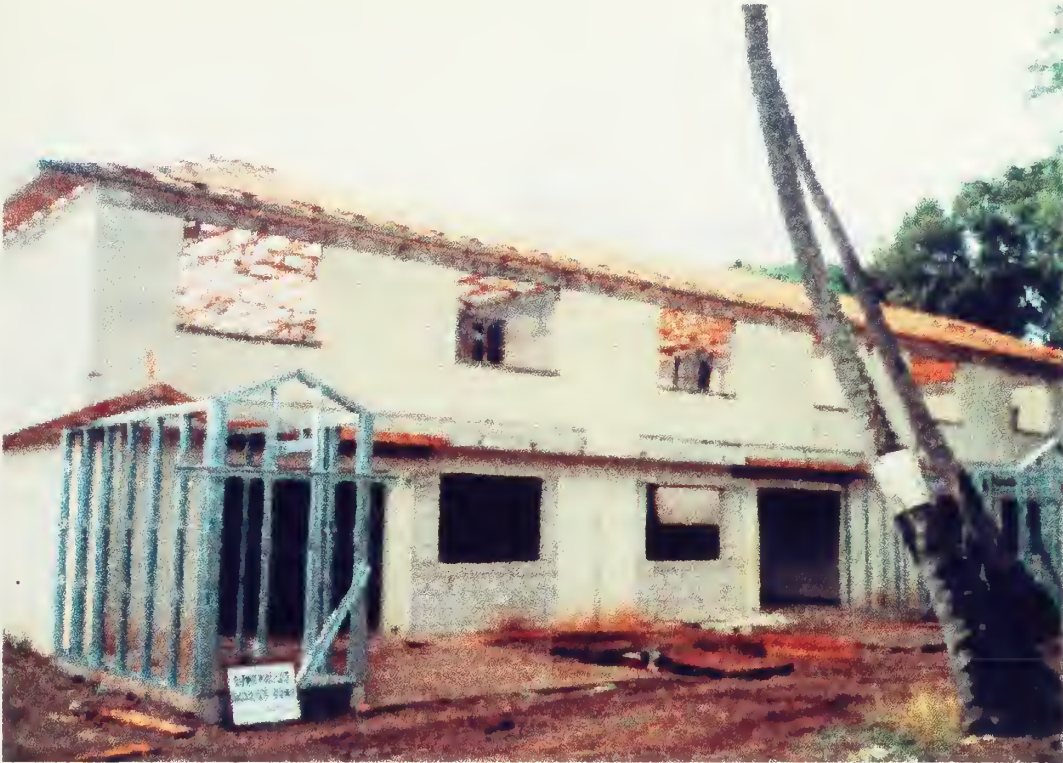
**Figure B.9: Renovation project, Hickam Air Force Base; fall protection plan (Note "controlled access zone" sign at left front corner of structure.)**

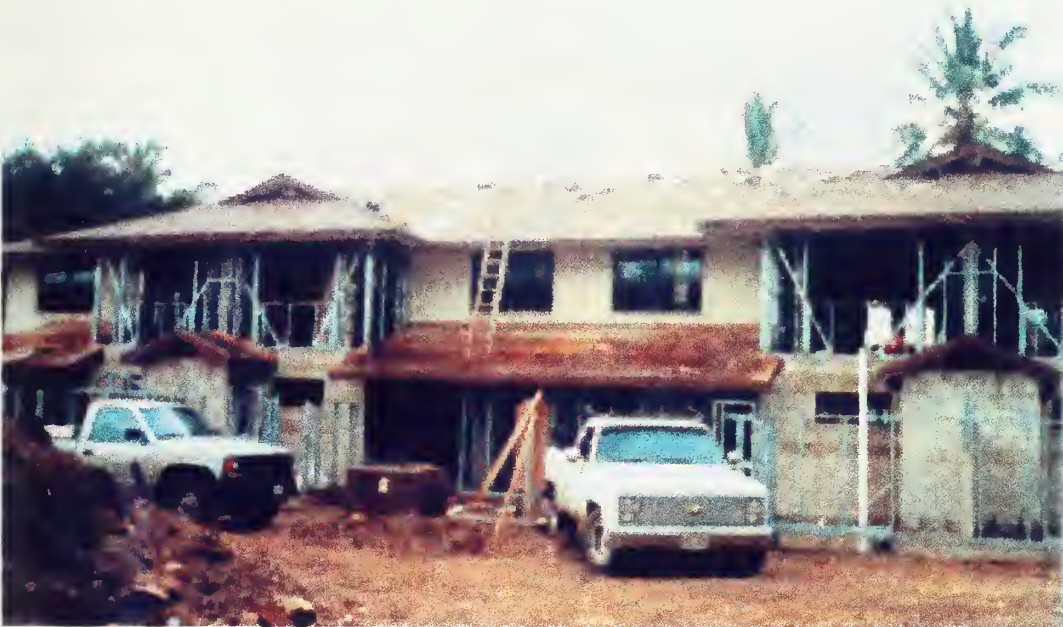
**Figure B.10: Renovation project, Hickam Air Force Base; fall protection plan (Note access to roof.)**

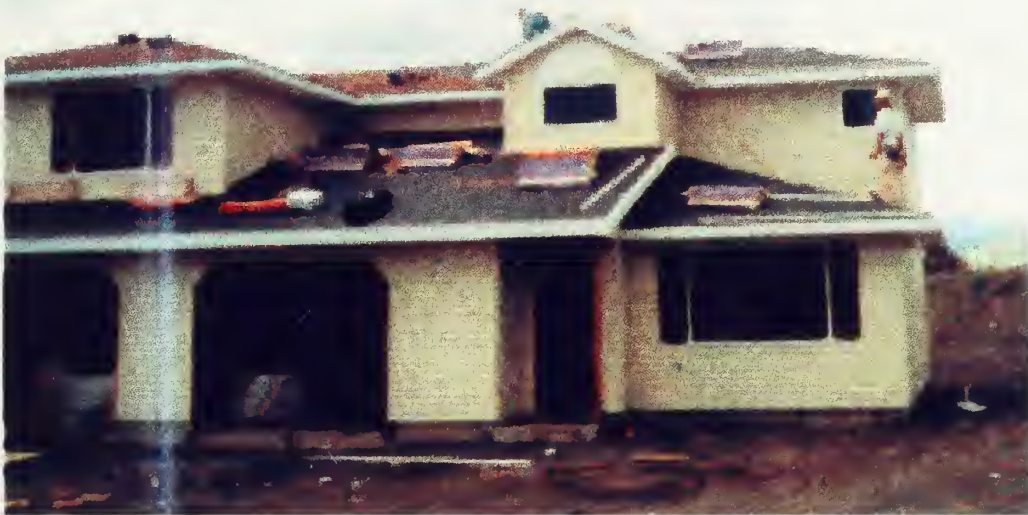
**Figure B.11: New construction, Moanalua Navy Family Housing, Pearl Harbor; Safe-T-Strap PFAS variant (Note strap attached to worker's PFAS.)**

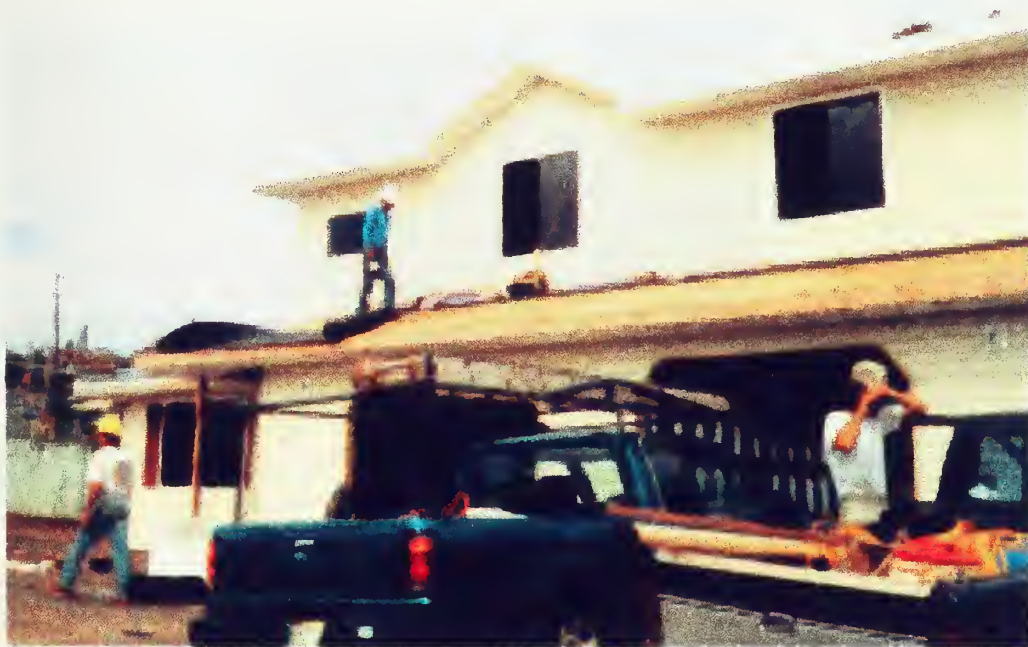
**Figure B.12: New construction, Moanalua Navy Family Housing, Pearl Harbor; Safe-T-Strap PFAS variant (Note strap attached to worker's PFAS.)**

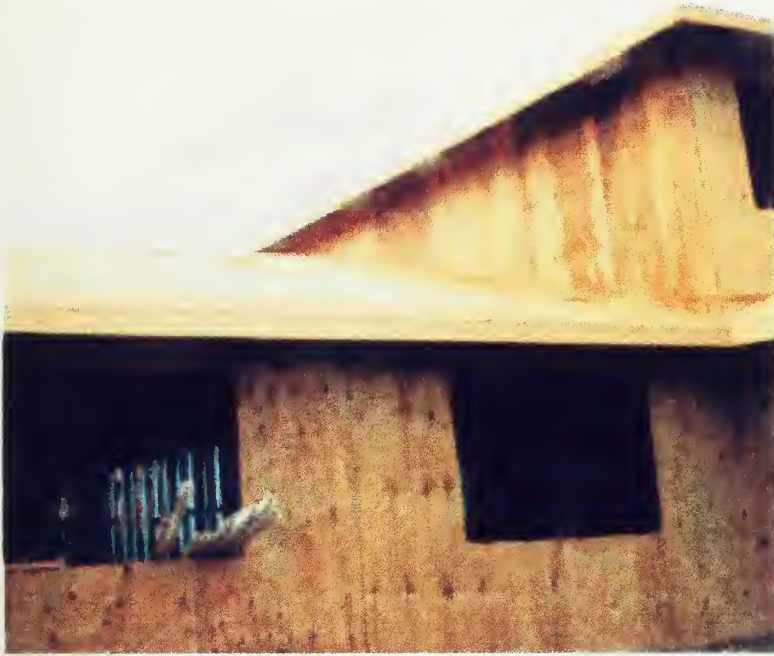
**Figure B.13: New construction, Moanalua Navy Family Housing, Pearl Harbor; Safe-T-Strap PFAS variant (Note strap hanging from ridge and proceeding down to right.)**

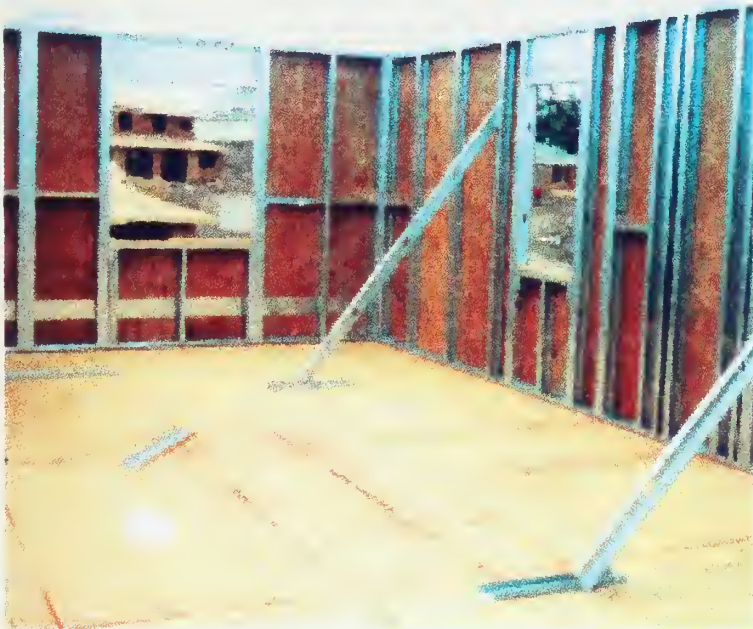
**Figure B.14: New construction, Moanalua Navy Family Housing, Pearl Harbor; use of alternative construction sequence to allow for placement of work platforms during truss installation (Note lack of interior frame walls.)**

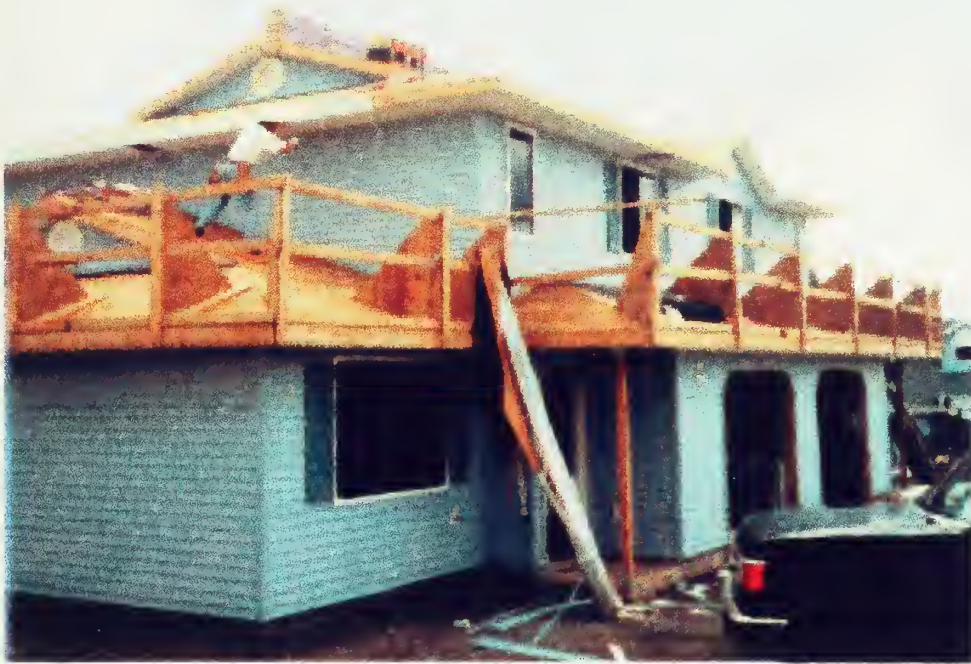
**Figure B.15: New construction, Moanalua Navy Family Housing, Pearl Harbor; guardrail system used in siding operations**

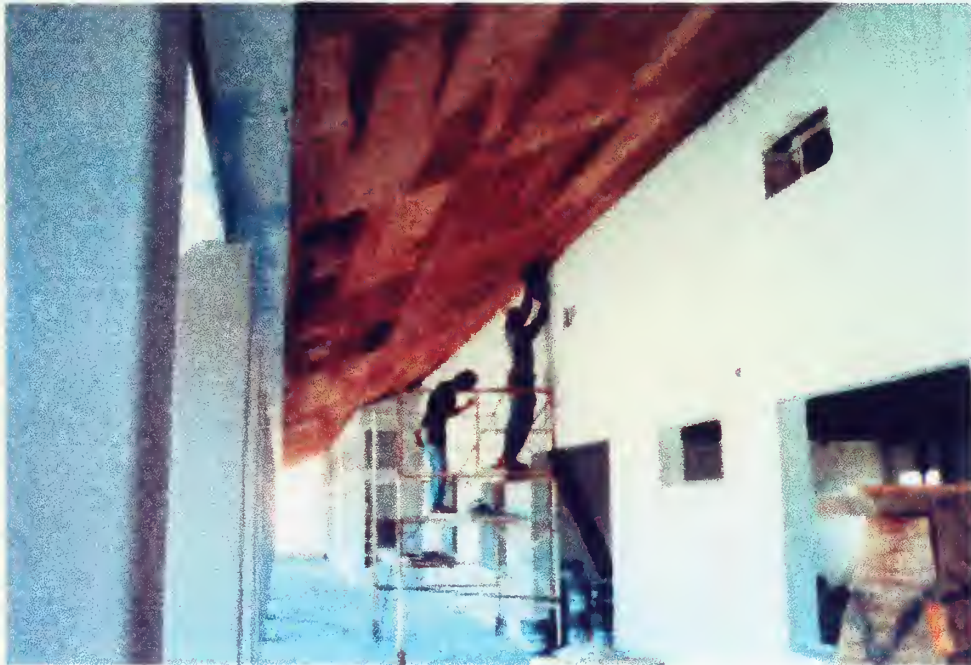
**Figure B.16: New construction, Child Development Center, Marine Corps Base Hawaii, Kaneohe; use of scaffolds for finish work**

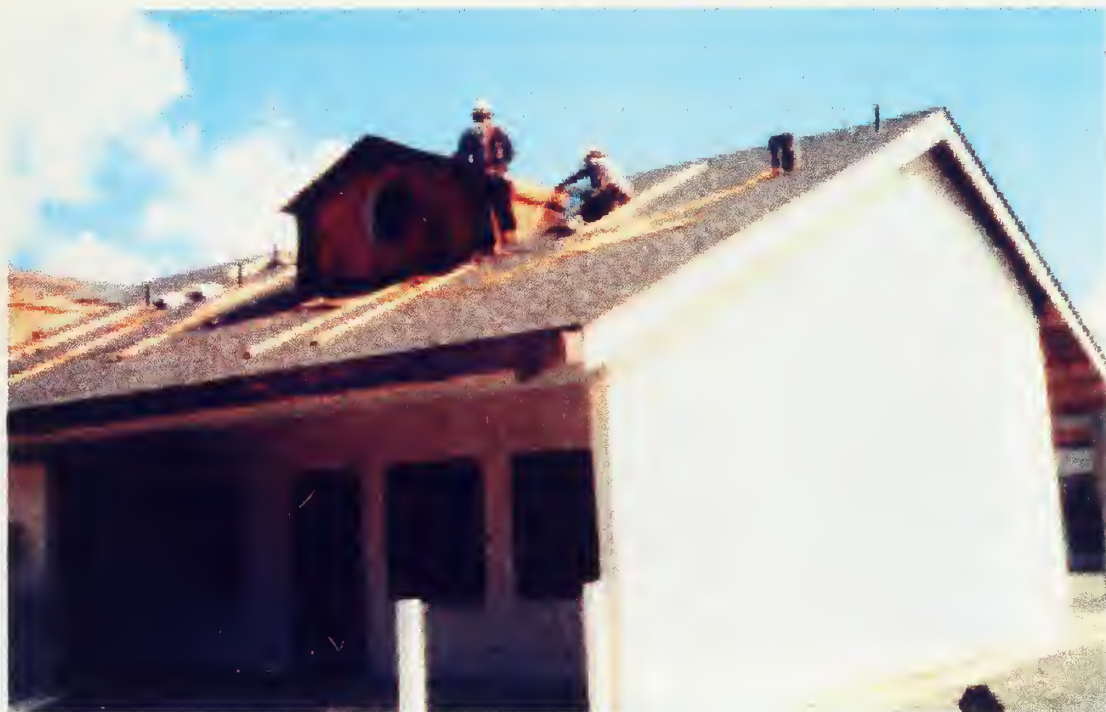
**Figure B.17: New construction, Child Development Center, Marine Corps Base Hawaii, Kaneohe; PFAS use (Note the anchorage for the worker's PFAS--a vent pipe!)**

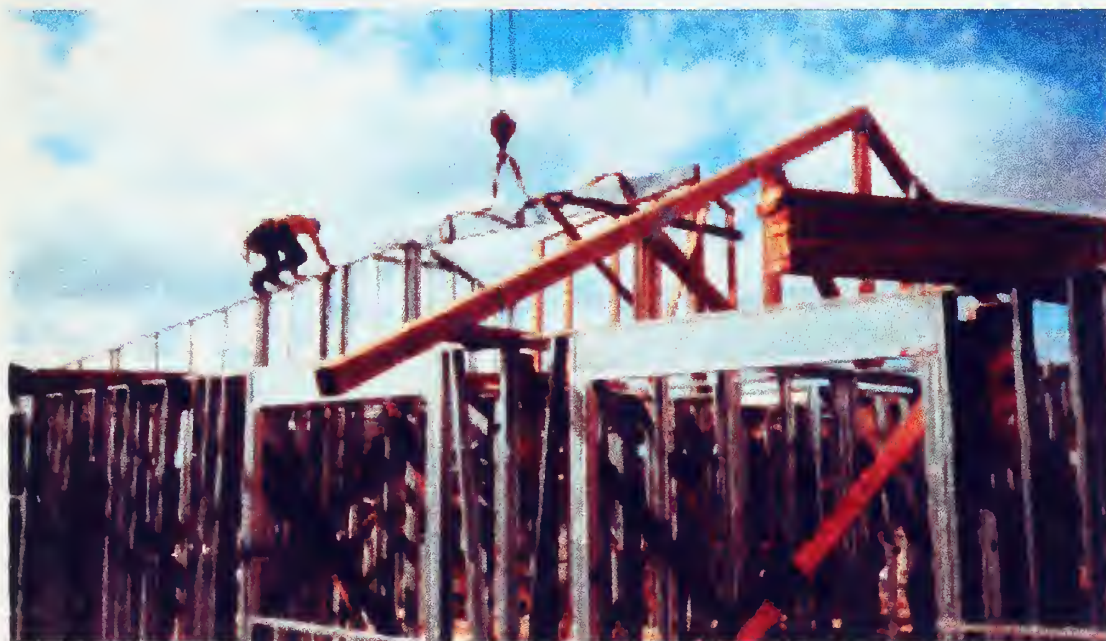
**Figure B.18: New construction, central Oahu; fall protection plan; setting the center ridge for half-truss installation (No protection is afforded to the worker.)**

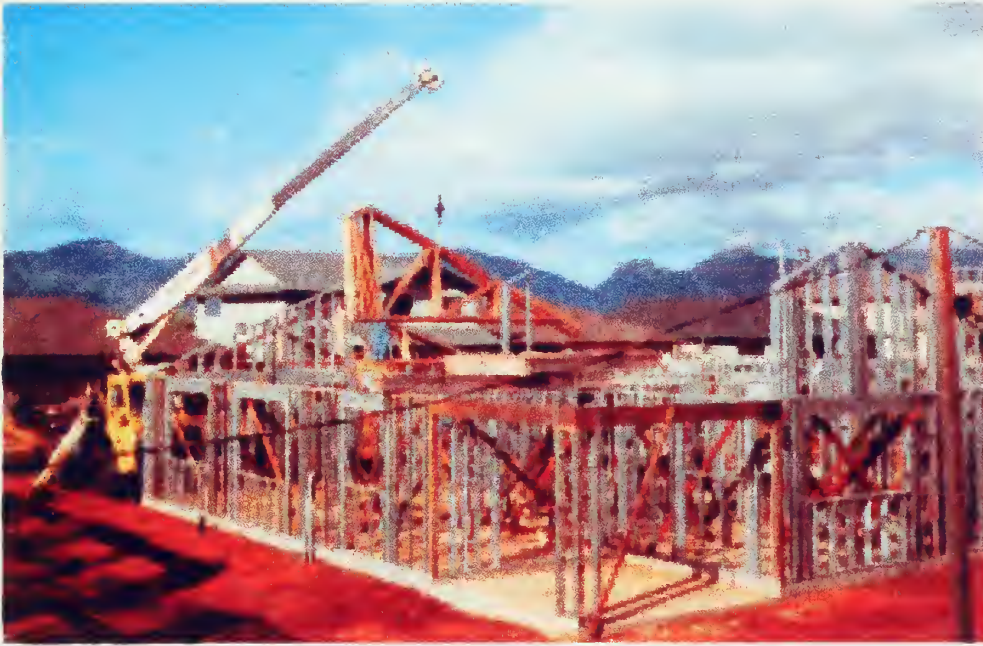
**Figure B.19: New construction, central Oahu; fall protection plan; truss delivery and placement on the top plates of frame walls (No protection is afforded to the worker.)**

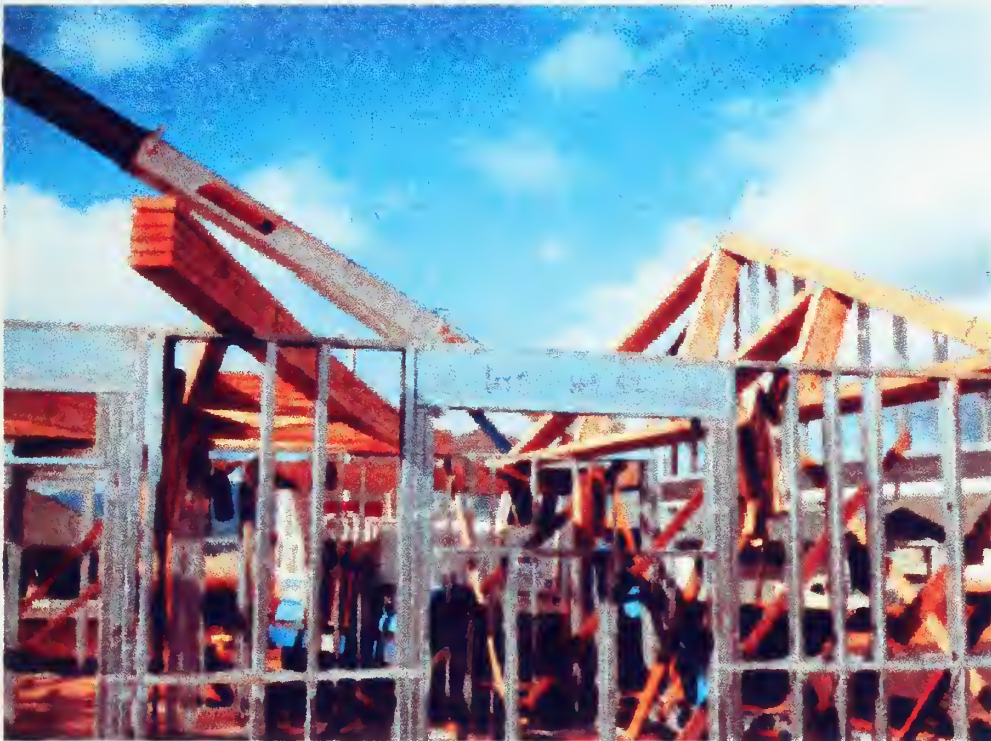
**Figure B.20: New construction, central Oahu; fall protection plan; trusses spaced in bundles along top plate for installation by framers**

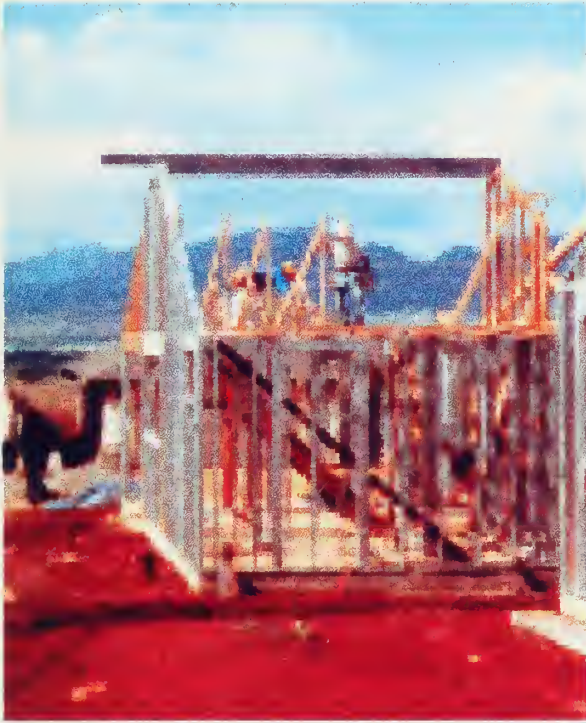
**Figure B.21: New construction, central Oahu; fall protection plan; truss installation--setting the trusses**

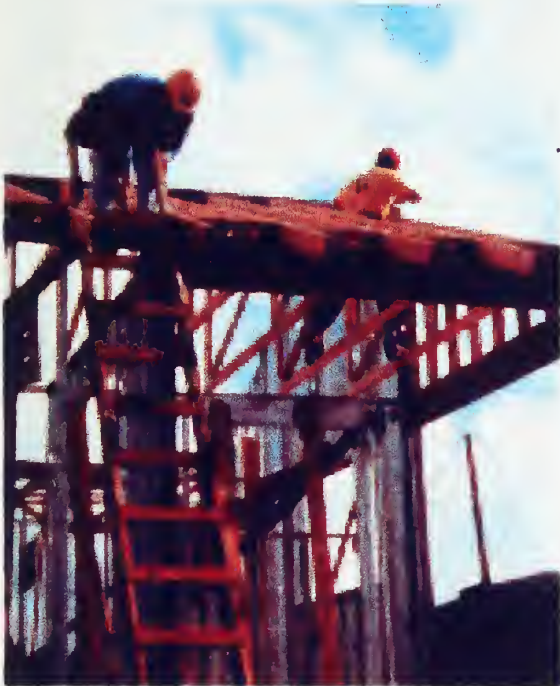
**Figure B.23: New construction, central Oahu; fall protection plan; truss installation--bracing the trusses**

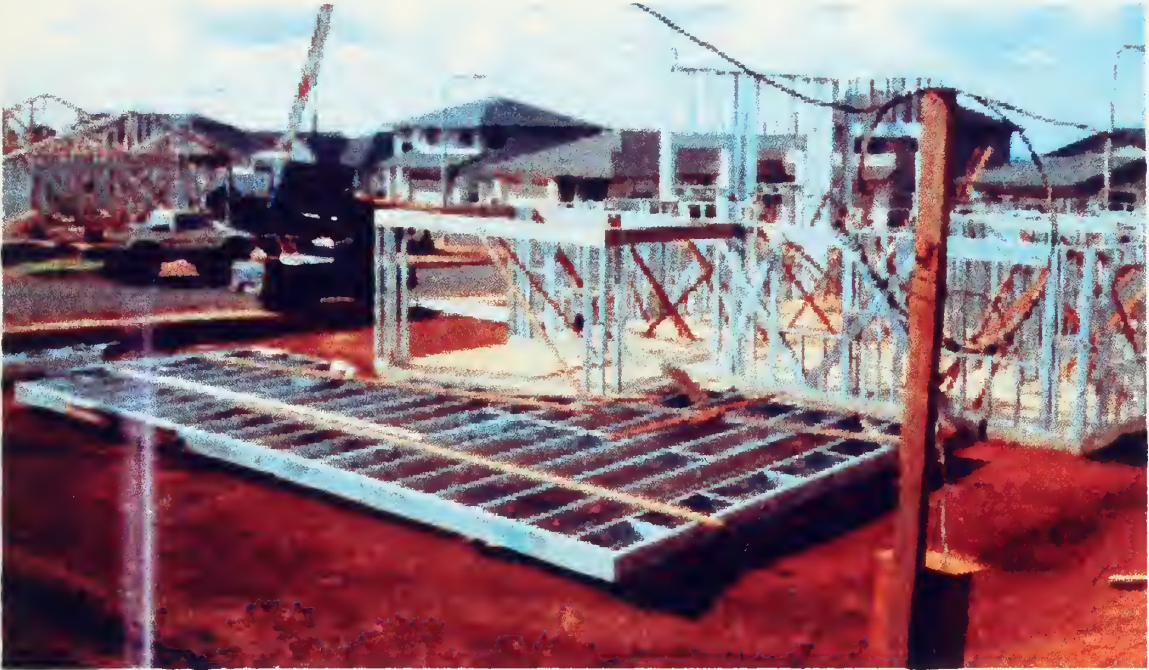
**Figure B.24:** New construction, central Oahu; prefabrication; prefabricated floor joist system, ready for lifting

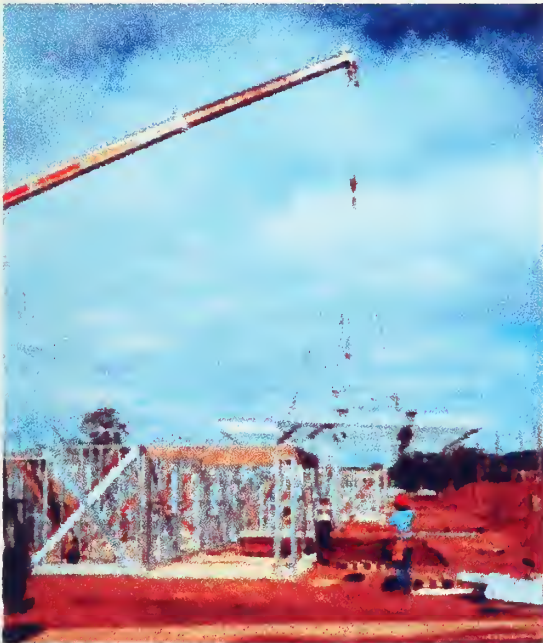
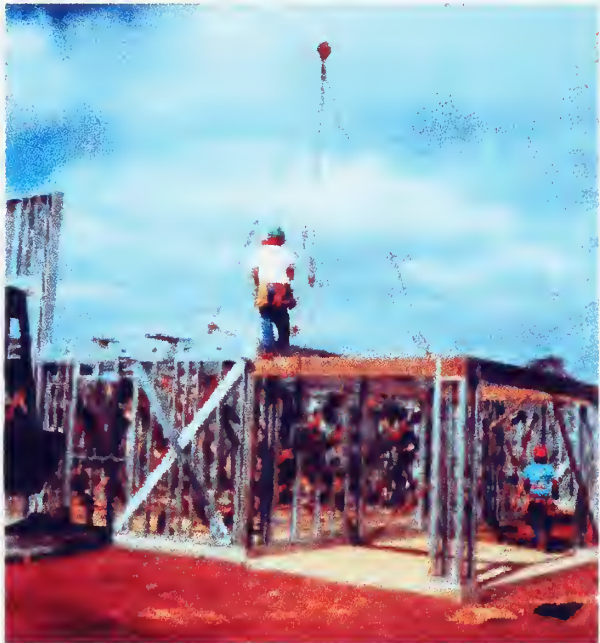
**Figures B.25 and B.26:** New construction, central Oahu; prefabrication; lifting and placing the prefabricated floor joist system

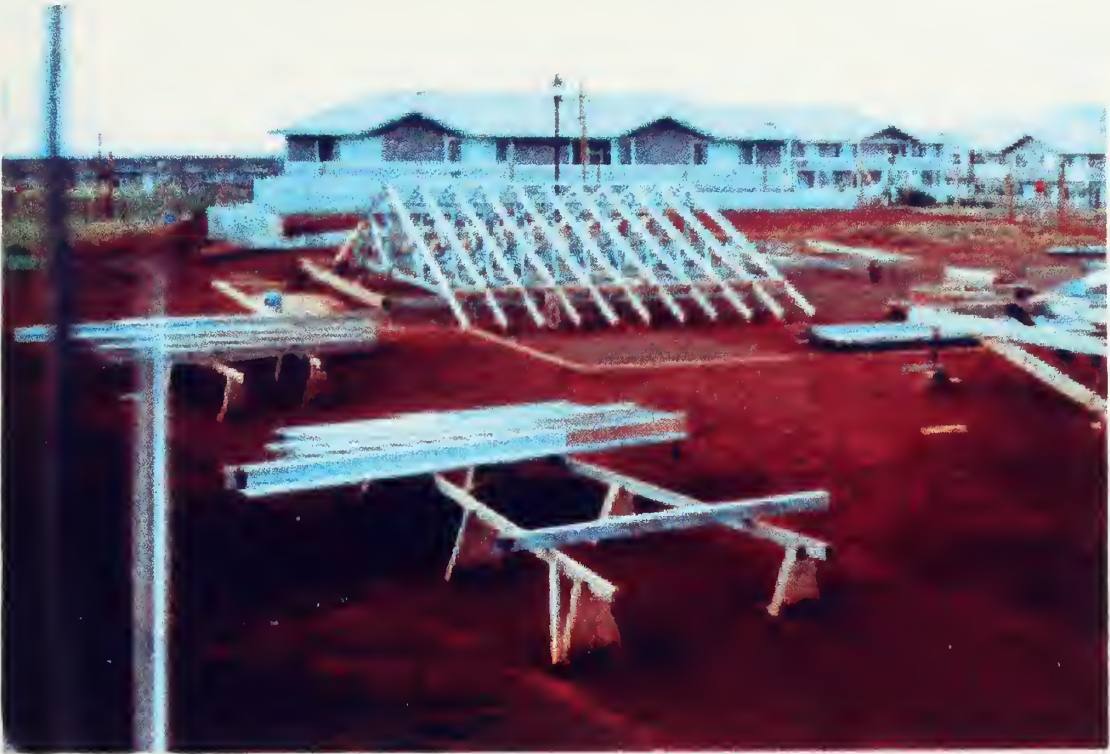
**Figure B.27: New construction, central Oahu; prefabrication; prefabricated truss system**
